**RE: Clean Harbors Wichita, LLC Part B
Tank Certification Statements**

Clean Harbors Wichita, KS facility Tank V-1 Hazardous Waste Storage

Conduct and internal and external visual and ultrasonic thickness evaluation of the inspection of Tank V-1 in accordance with the API 653 Code regulations and guidelines.

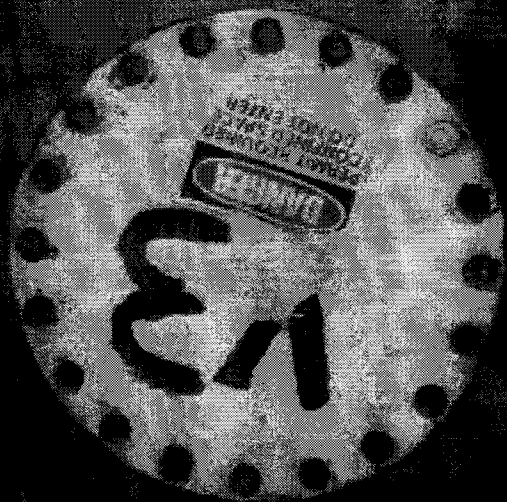
Areas of
paint
failure

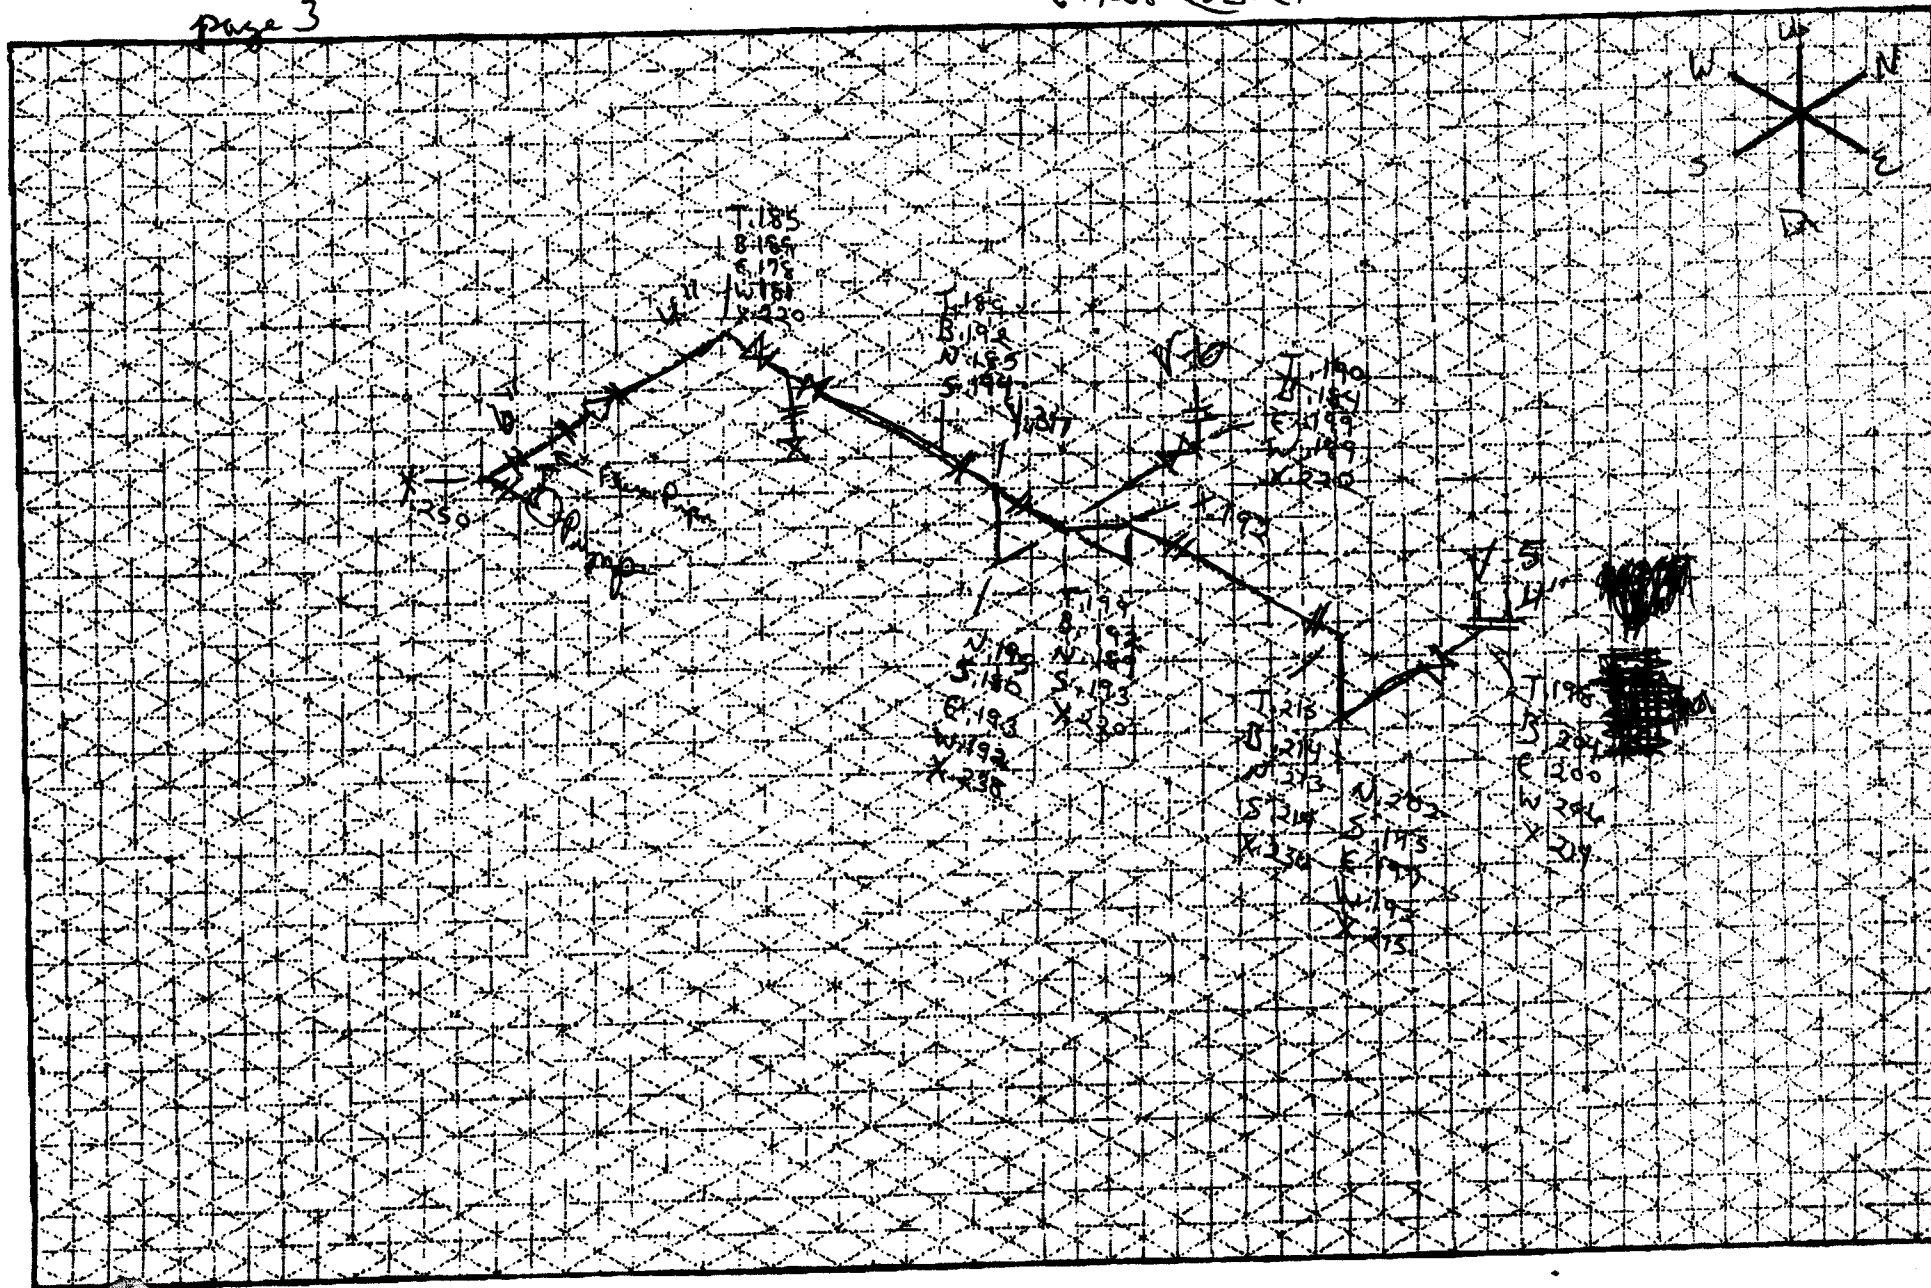
The inlet piping approximately four feet upstream from the pump situated in the north/south direction has two welds that do not have an acceptable amount of weld build up. The rest of the piping welds are in acceptable condition.

The piping coating is deteriorated through out the unit.

Recommend a coating be put on the piping for protection from environmental conditions.
